# Hydrology Report for the Sheep Chicken VMP

By Dana M Nave, 5 March 2021

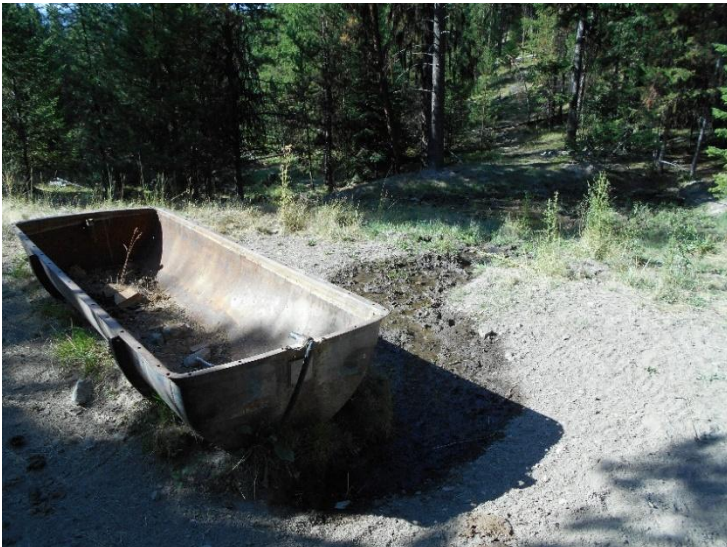
| Name | Condition Spring/Pond* | Comments/Issues | Recommendation | Allotment |
|---|---|---|---|---|
| Pine Tree Trough | Not functioning | Inlet pipe cut and dribbling water onto the ground which flows to small pond in draw several feet away and infiltrates about 30 feet below pond. Trough is dry, rusty and has holes. Wet soils are trampled but limited in aerial extent. | Replace trough; fix inlet & outlet pipes; install escape ramp | Sheep Ranch |

Pine Tree Trough not functioning

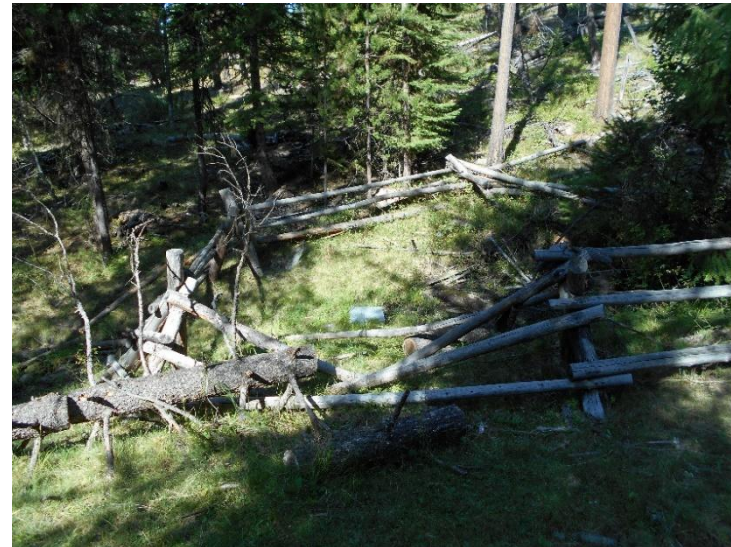
| Name | Condition Spring/Pond* | Comments/Issues | Recommendation | Allotment |
|---|---|---|---|---|
| Mattock Trough | Functioning | Exclosure fence is partially down around spring source in draw. Draw is wet and trampled between springbox and trough. Trough is dry, in good condition and needs sticks cleaned out. Escape ramp in good condition. Wet soils are trampled but limited in aerial extent. | Expand exclosure fence to include 70 feet of draw downstream. | Sheep Ranch |

Mattock Spring source area not protected

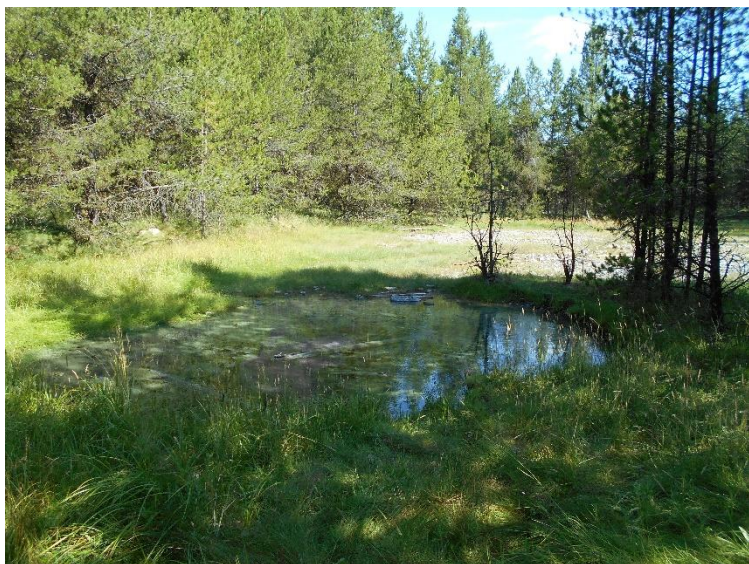
| Name | Condition Spring/Pond* | Comments/Issues | Recommendation | Allotment |
|---|---|--|--|---|
| Warm Mineral Springs Pond | Spring area; not a development | Pond in good condition when inventoried | None | Sheep Ranch |

Warm Mineral Springs Pond in great condition

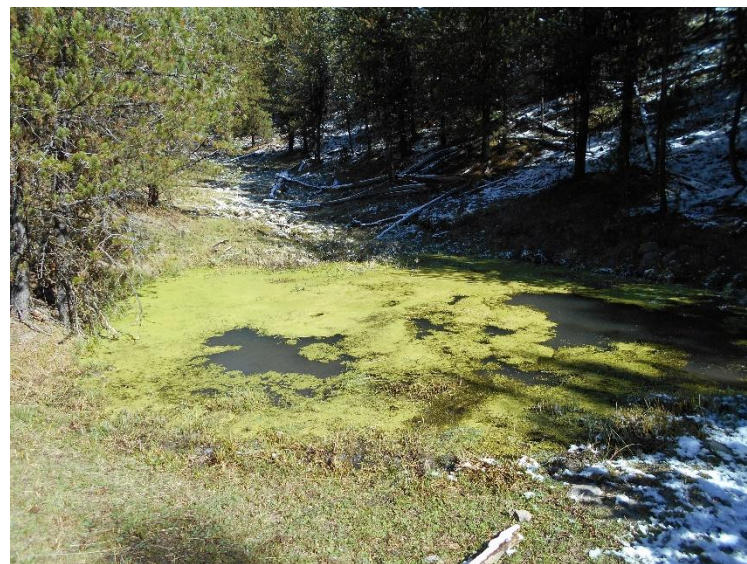
| Name | Condition Spring/Pond* | Comments/Issues | Recommendation | Allotment |
|---|---|---|---|---|
| M Avenue Pond<br>(also a water right) | Functioning | Small pond in draw with water. Water in draw above and below pond. Light-to-moderate trampling in draw above pond. | More frequent herding | Sheep Ranch |

M Ave Pond; channel light-to-moderately trampled and browsed

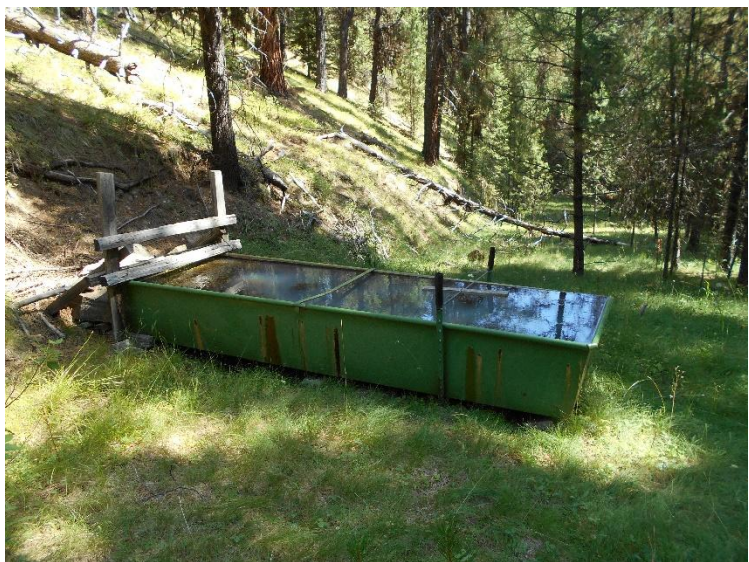
| Name | Condition Spring/Pond* | Comments/Issues | Recommendation | Allotment |
|---|---|--|--|---|
| Lower Sheep Trough | Functioning | Trough full of water. Small enclosure around spring source on road edge. Trough has no outlet pipe but no trampling observed during inventory. Needs an escape ramp. | Install escape ramp | Sheep Ranch |

Lower Sheep Spring and Trough in great condition with good flow

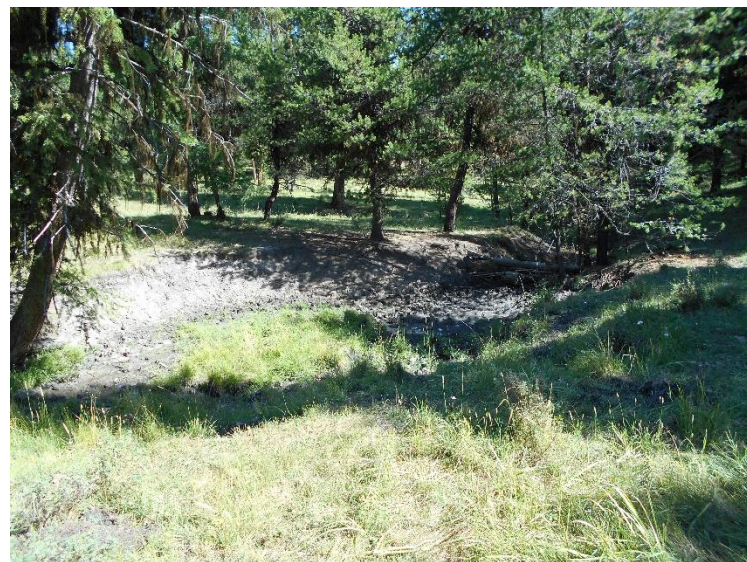
| Name | Condition Spring/Pond* | Comments/Issues | Recommendation | Allotment |
|---|---|--|--|---|
| Sheep Trib Spring | Spring area; not a development | Source area for intermittent channel below; getting lots of livestock/wildlife use; heavily trampled; locally eroding stream channel and banks | Protect with fence; perhaps install springbox/trough away from channel | Sheep Ranch |

Sheep Trib Spring source area not protected and heavily trampled
